The fire resistance performance of two single leaf single acting doorsets with glazing, when tested in accordance with BS 476: Parts 20 and 22: 1987

403484 Rev A

**Vistamatic Ltd**

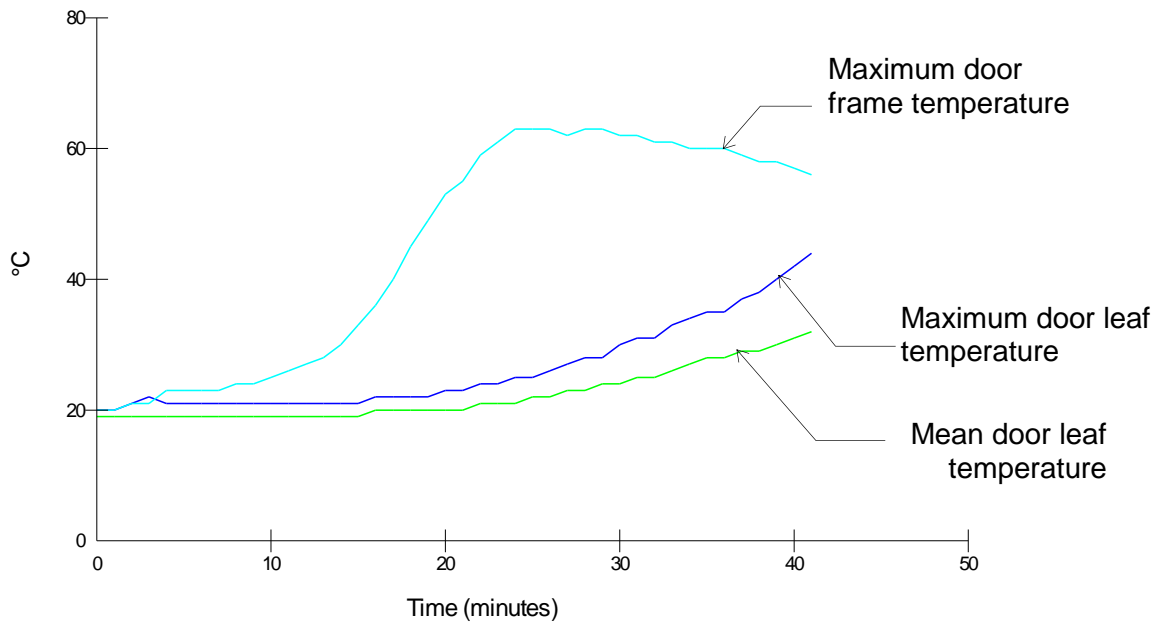
### Doorset A

The temperature of the unexposed face of both doorsets was monitored by means of five thermocouples fixed to the surface of the door leaf and three thermocouples attached to the frame, one at midheight on each jamb and one centrally located above the leaf on the frame head. Two additional thermocouples were fixed to the glass.

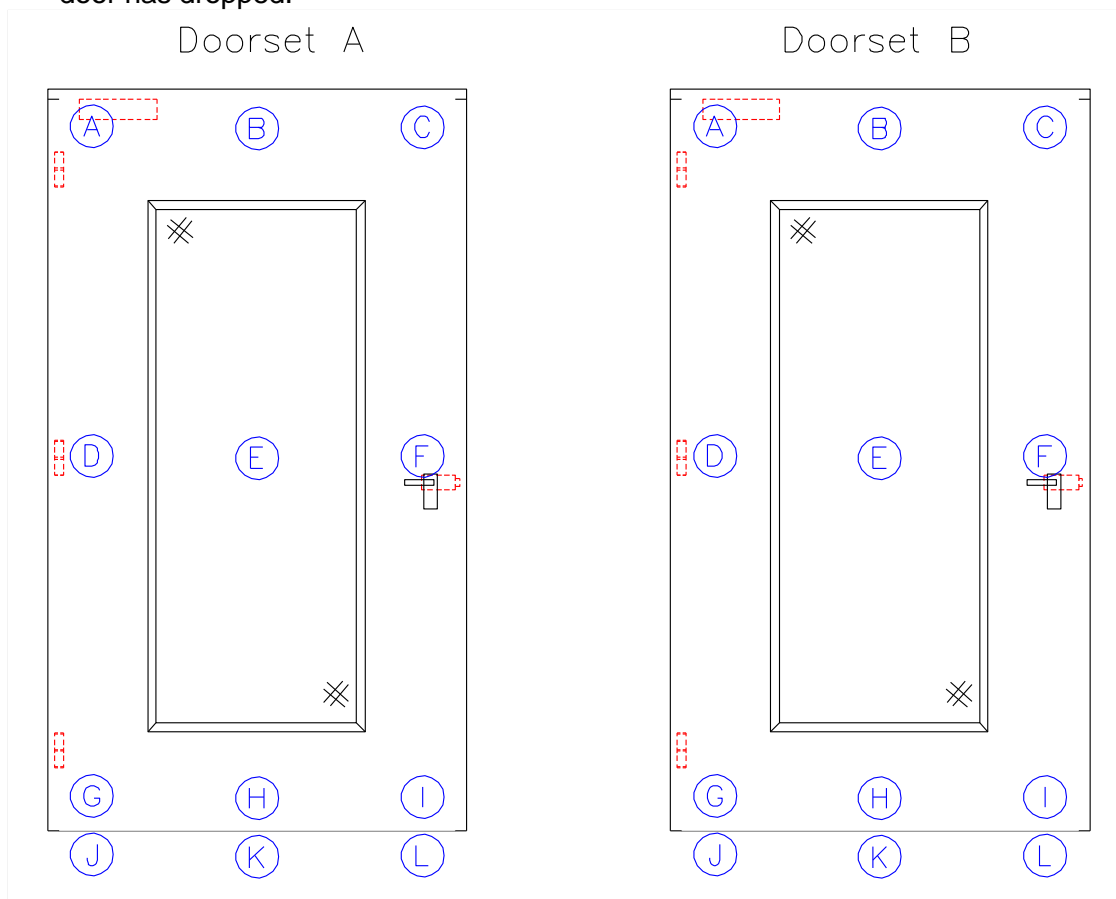
The following tables show the distortion of the door in mm with an accuracy of  $\pm 1$ mm. A positive measurement indicates distortion towards the furnace. A negative measurement indicates distortion away from the furnace. J, K and L give vertical movement of the door, a negative reading indicates that the door has dropped.

Time	A	B	C	D	E	F	G	H	I	J	K	L
10	6	7	9	-7	-1	1	9	-6	2	-1	3	-2
20	6	1	11	-17	-1	2	11	-5	6	-1	-1	-3
30	6	9	12	-6	-2	12	11	-4	8	-3	-3	6

Time	A	B	C	D	E	F	G	H	I	J	K	L
10	3	0	4	1	1	-3	1	1	4	-1	0	-2
20	2	-1	5	1	4	-3	1	2	4	-2	-3	-3
30	6	-1	10	2	5	0	2	1	9	-3	-3	-3

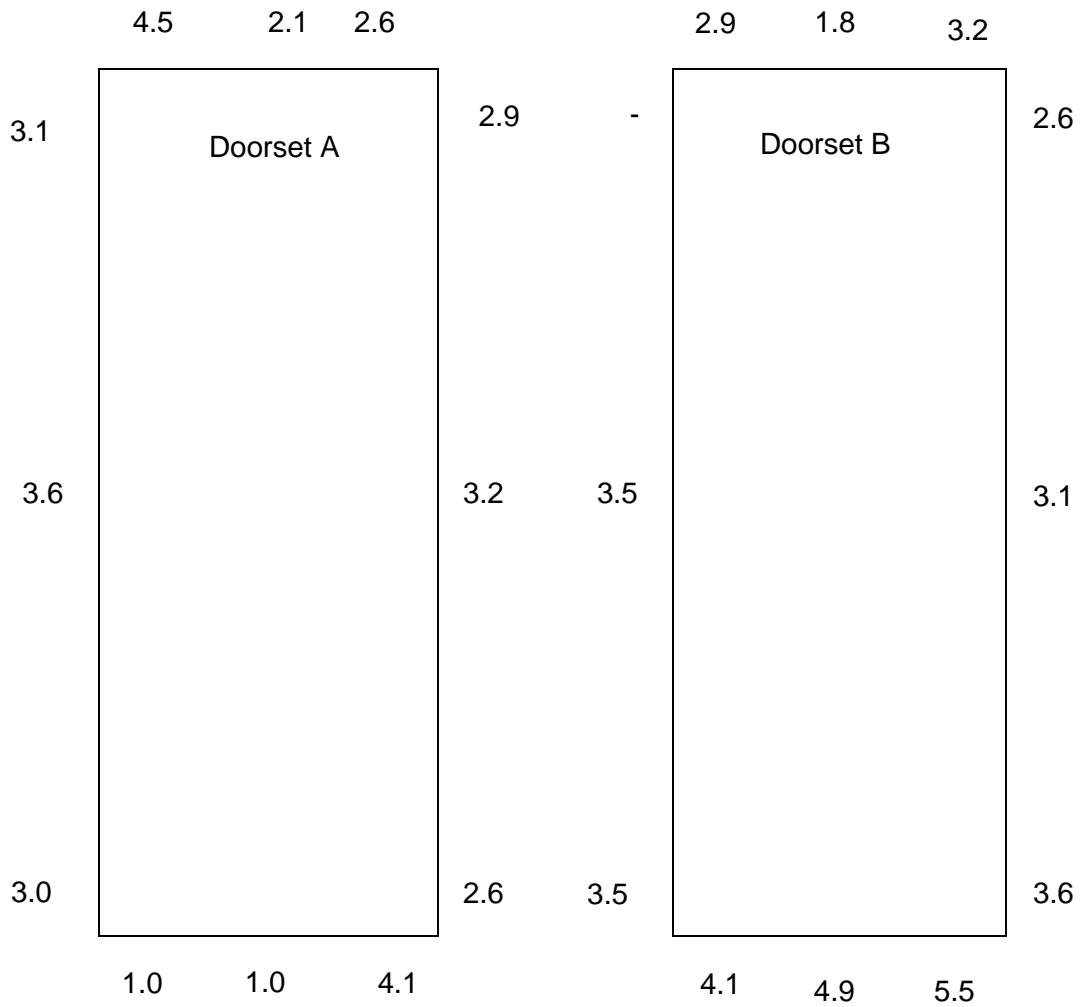
#### 5.4 Door leaf to frame gaps

The gaps between the edge of the door and frame were measured prior to test. A total of 24 readings were taken. The measurements (in mm) are given in Section 5.4 of this report.

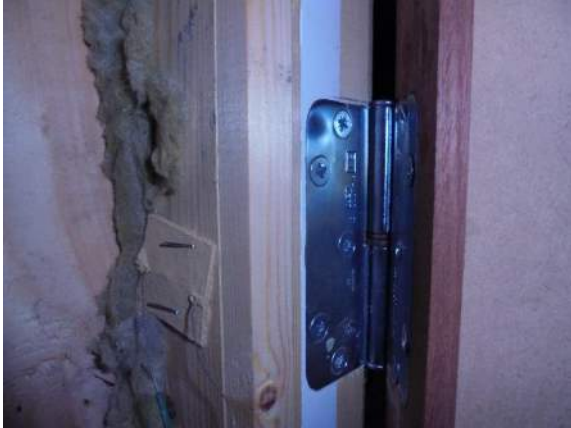
Around hinge blade – doorset A

Make/type	Size (mm)	Location
Around hinge blade	Partially interrupted	-	Hinge blade partially interrupts the seal in the frame reveal leaving the 2mm continuous
Under hinge blades	Interdens	1 thick	Fitted under the hinge blade on frame and leaf
Encasing latch body	Interdens	1 thick	Fitted around the body of the latch
Under latch forend	Interdens	1 thick	Fitted under the latch forend
Around latch keep	Fully interrupted	-	Latch keep fully interrupts seal in frame reveal
Under latch keep	Interdens	1 thick	Fitted under the latch keep

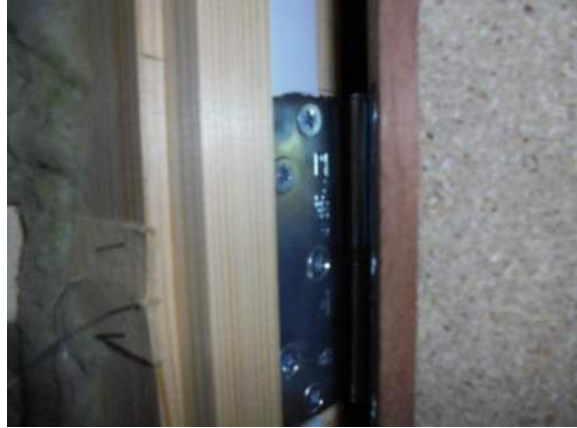
Around hinge blade – doorset B

Make/type	Size (mm)	Location
Around hinge blade	Fully interrupted	-	Hinge blade fully interrupts the seal in the frame reveal
Under hinge blades	Interdens	1 thick	Fitted under the hinge blade on frame and leaf
Encasing latch body	Interdens	1 thick	Fitted around the body of the latch
Under latch forend	Interdens	1 thick	Fitted under the latch forend
Around latch keep	Fully interrupted	-	Latch keep fully interrupts seal in frame reveal
Under latch keep	Interdens	1 thick	Fitted under the latch keep

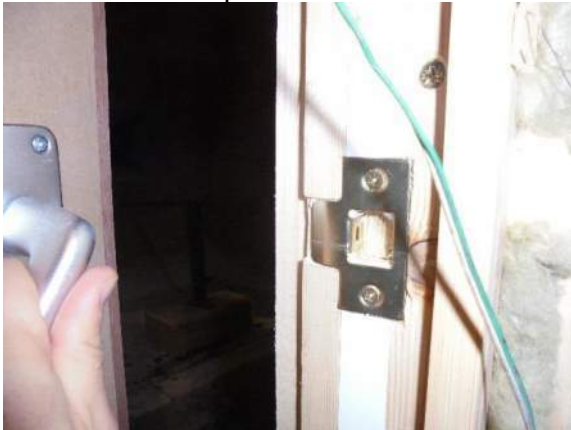
Around latch keep – doorset A

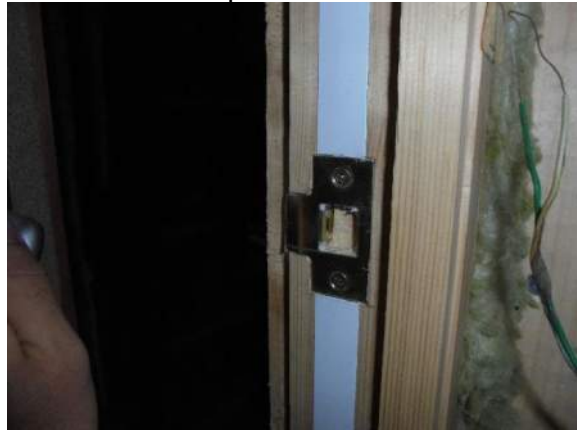
Around latch keep – doorset B
